The Capitol Power Plant

The OOC conducted a comprehensive inspection of the U.S. Capitol Power Plant (CPP) during the 111th Congress. The facility provides steam for heating and chilled water for cooling Capitol Hill buildings, but does not produce electrical energy for the Capitol campus. The CPP includes the Administration Building; the newly expanded West Refrigeration Plant (the East Refrigeration plant is being removed from service); the Boiler Building, which houses boilers, a bag house, storage areas, shops, a communication center and two smoke stacks; an ash collection building; three office trailers; two cooling towers; a coal yard including off-loading facilities for rail cars and an underground oil storage tank; a coal conveyor tunnel; a Hazmat storage shed; an emergency generator shed; the Blue Storage Building; Load Center One Building; several contractor trailers; two US Capitol Police kiosks; and the transfer building.

111th Congressional Inspection Findings

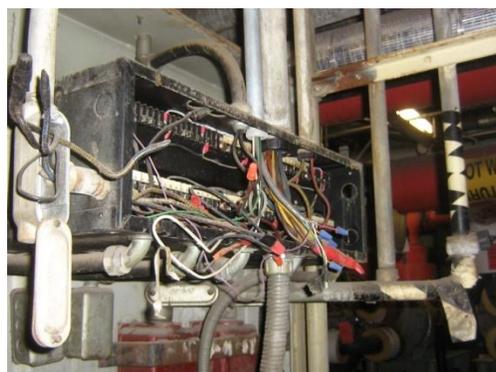
Picture 1: Back Electrical Cover Missing On Control Panel

to contact energized components inside the panel box.

Twenty-two electrical panel covers were discovered to be missing from electrical junction boxes leaving wires exposed that could cause electrical shock. See Picture 1. A number of electrical panels had incomplete or missing directories for the individual circuit breaker service. This has the potential to expose employees to hazards and may lead to serious injury if the wrong circuit is deactivated or locked out during maintenance or repair of equipment. Several electrical panels had missing or broken latches, leaving the internal mechanisms exposed to potentially corrosive dust. There were also several panels without a dead front, which could permit employees inadvertently

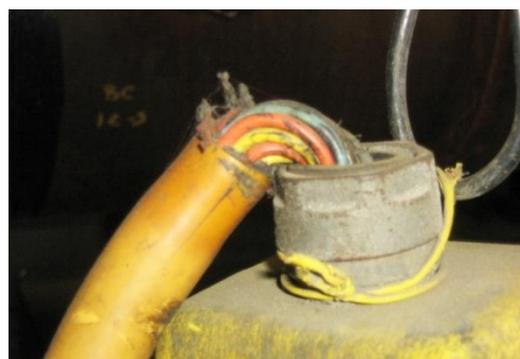
The inspectors noted ground fault circuit interrupters (GFCIs) missing from two electrical outlets near sinks in the basement of the Boiler Building. A GFCI on the first floor of the building was broken and would not trip. Inside a restroom near a sink, a GFCI was found loose in its bracket. Further problems with electrical cords were also noted. See Picture 2.

Picture 2: Electric Cord Pulled Away From Mounting

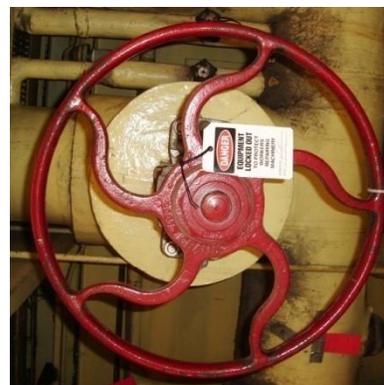
Lockout/Tagout deficiencies were observed during the inspection. The Power Plant does not appear to have implemented a comprehensive Lockout/Tagout program that complies with OSHA standards. This hazard was observed during the 110th Congress biennial inspection. During the 111th Congress inspection, the inspectors recorded these hazards as one general finding that an adequate program had not been implemented. This hazard puts employees at risk of injury from electrical, mechanical, thermal or stored energy including high voltage equipment. If these energy sources are not neutralized or controlled, equipment could accidentally start up during maintenance or repair, causing fatality, amputation or other serious injury. An unplanned startup could also damage CPP equipment or property. See Picture 3.

Picture 3: Valve Needs To Be Locked Out, Not Just Tagged

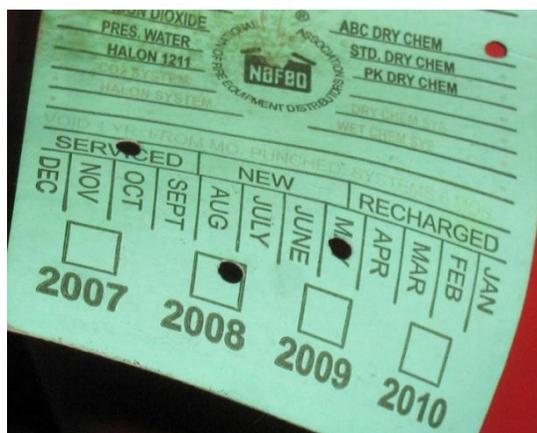
Picture 4: Tag On Portable Fire Extinguisher Indicates Last Inspection in 2008

The inspectors found six locations where fire wall openings would allow the penetration of smoke and toxic gases into an adjacent fire zone during a fire. Five instances of unsafe electrical space heaters were discovered. Four instances were recorded where lighting cables were not reconnected to the ground cables after work had been completed in those areas. Portable fire extinguishers were discovered that had not been inspected in over two years. See Picture 4.

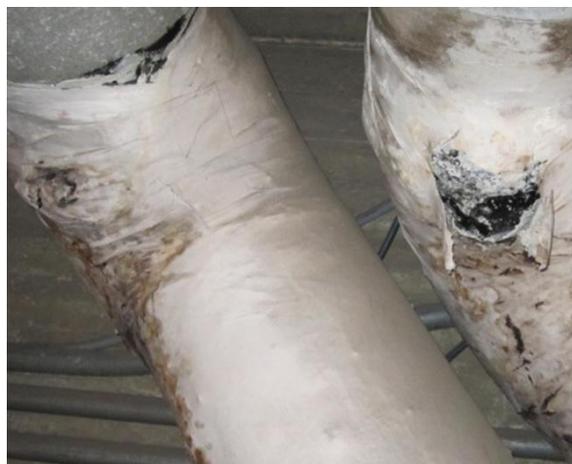
Each building serviced by the CPP has a vault or room known as a steam station where high pressure steam is reduced to a lower pressure and distributed throughout the building. The inspectors found a number of hazards in these areas, including friable asbestos lagging, a failure to test pressure relief valves, and potential weakness in steam lines due to corrosion. See Picture 5.

Picture 5: Cloth Pipe Lagging Covers Are Ripped Open Exposing Friable Asbestos Insulation

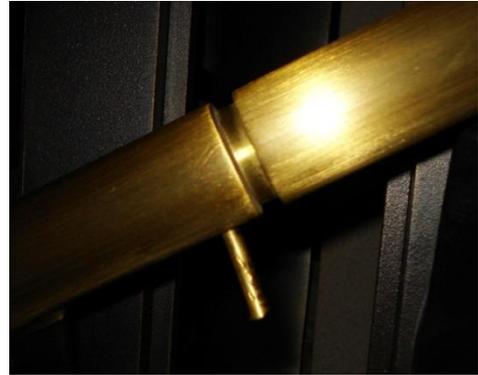
confined spaces that lacked required warning signs. However, AOC indicated the areas will be evaluated and signs installed by the end of 2011. Four instances were found where space heaters lacked a protective tip-over switch. Only one instance was found for inadequate machine guarding and one instance was found for an unlabeled hazardous chemical container. Picture 1 displays a connector pin protruding from a newly installed handrail. This pin could easily injure a person's fingers. After inspectors brought this problem to the AOC's attention, contractors quickly sawed off the pin and made the surface smooth.

Picture 1: Brass Connector Pin Protruding From Handrail

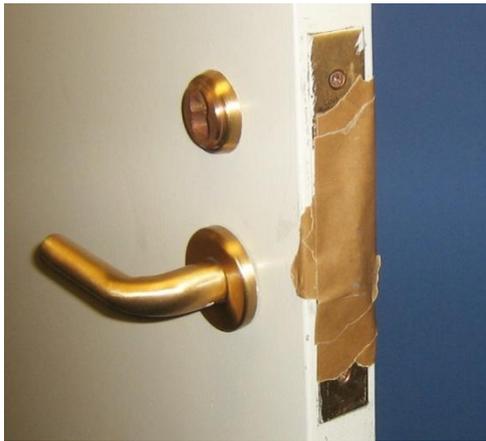
close and latch by themselves in an emergency so that fire, smoke and other toxic gases do not easily move into other fire zones. Picture 3 is a push-to-talk device in a stairwell so that building occupants can easily contact the U.S. Capitol Police in an emergency if they need assistance. This device is well-marked and readily accessible to Members, staff and visitors alike. Picture 3 is an excellent example of a system that meets OSHA and fire code requirements.

Picture 2: Fire Door Latch is Taped Open

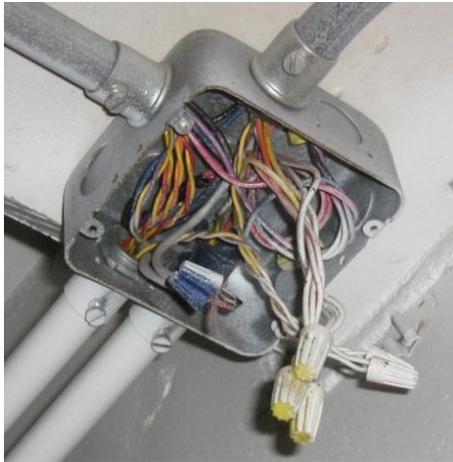
Electrical hazards were the most common findings across all RAC levels. Of the 52 RAC 2 electrical findings, there were 26 missing electrical covers (See Picture 1), 9 electrical outlets and switches, 7 miscellaneous electrical hazards, 7 electrical panels hazards, and 3 improper use of extension cords. The inspectors found 41

Picture 1: Open Electrical Junction Box

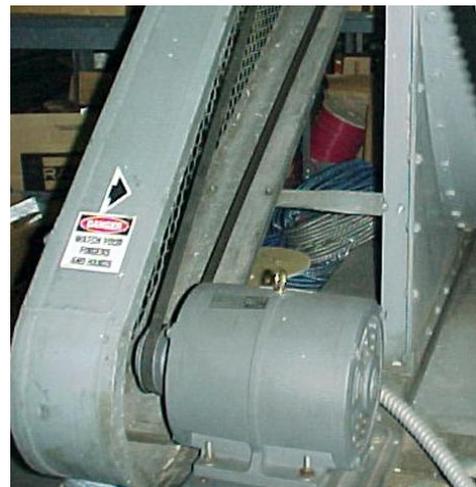
The 111th Congress inspection identified four machine guarding hazards. See Picture 2. This was 42% lower than the number of such hazards found in the previous Congress. The fire sprinkler system presented multiple hazards, including non-approved Omega sprinkler heads, sprinkler heads that had been spray-painted, and others that were covered with dust and dirt. In one case sprinkler heads had been installed upside down. The team noted a lack of required documentation stating that the fire sprinkler system is visually inspected annually and tested periodically.

Picture 2: Inadequate Guard Over V-belt & Pulley

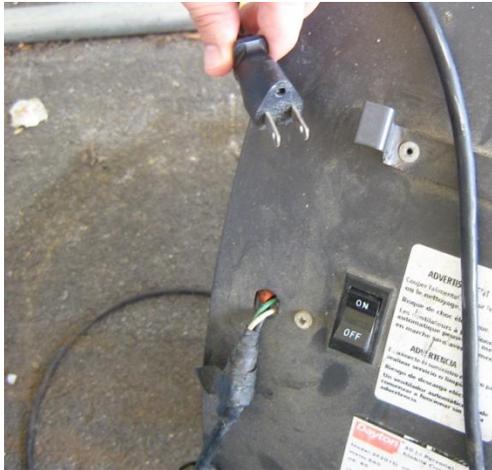
Picture 1: The Plug Is Missing A Ground Prong & The Cord Has Been Pulled From The Device

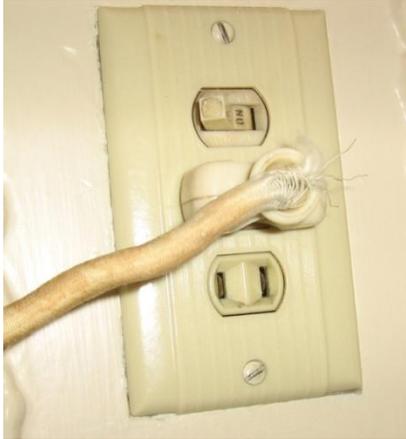
Picture 1: Two Prong Electrical Outlets Must Be Replaced With 3 Prong Outlets

The inspection team noted 12 GFCI violations. These hazards could cause electrical shock. Four electrical junction boxes had exposed wires and lacked a firmly affixed cover. There were six electrical panels missing breaker position covers or lacking a dead front. This was a 40% decrease from the 110th Congress. These deficiencies were remedied during the inspection cycle. The team found a number of two-prong outlets, which are hazardous because they are not grounded. See Pictures 1 and 2.

These old style receptacles were later replaced with three-prong, grounded outlets.

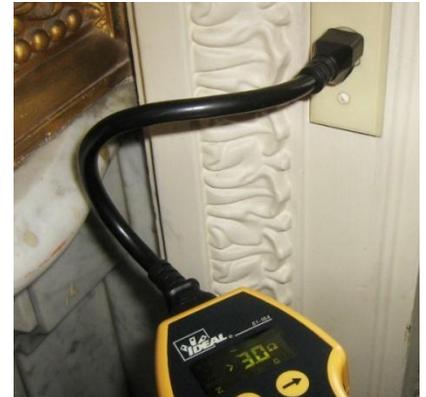
Picture 2: Displays Receptacle With High Impedance

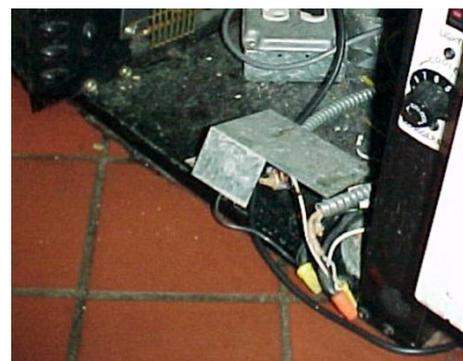
As Figure 5 indicates, 50% of the hazards that the team found involved electrical issues. These hazards include deficiencies with outlets, electrical covers, cords, plugs and electrical panels. See Figure 6. The inspectors noted a high incidence of exposed live wiring behind outlets and switches, as well as in damaged cords and plugs. See Picture 1. The team found 56 Ground Fault Circuit Interrupter (GFCI) hazards, including 13 broken GFCIs. These devices can quickly cut the power when a short is detected. Forty-three locations were identified where GFCIs should have been installed and were not. In 35 of these cases, outlets located less than six feet from a water source lacked requisite

Picture 1: Open Electrical Box.

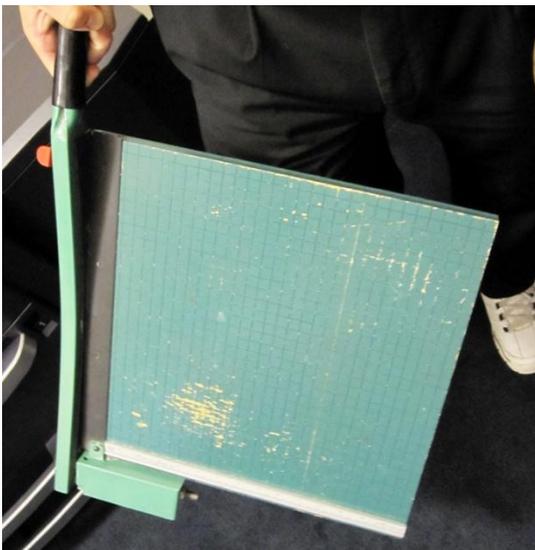
The inspectors found nine hazards associated with missing or inadequate machine guarding. Although this represents a small percentage of the total, see Figure 5, these hazards can be very serious. Inspectors found paper cutters that lacked appropriate finger guards. See Picture 2. The team also identified missing or broken guards on portable electric fans. In workshops, the team found several saws and bench grinders that lacked guards to prevent the operator from reaching into the point of operation.

Picture 2: Missing Finger Guard

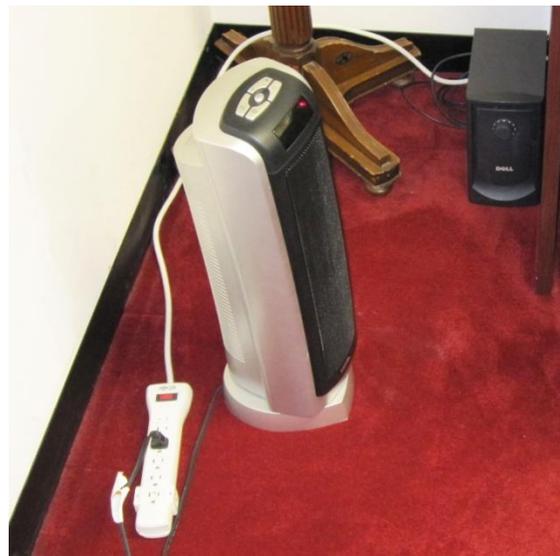
Fire safety hazards were documented in 329 findings. Problems with portable electric space heaters accounted for 105 findings. See Picture 3. Ten of the space heaters had broken parts such as legs or mounts. Most lacked a tip-over switch to shut off the heat if the device were turned on

its side; this prevents the coils from heating carpet or flooring to the point of catching fire. The inspectors found 18 such heaters in the Cannon Building, 23 in the Ford Building and 50 in the Rayburn Building. We understand that the CAO has prepared a list of space heaters featuring tip-over switches that could replace the non-compliant devices.

Picture 3: Portable Space Heater No Tip Switch

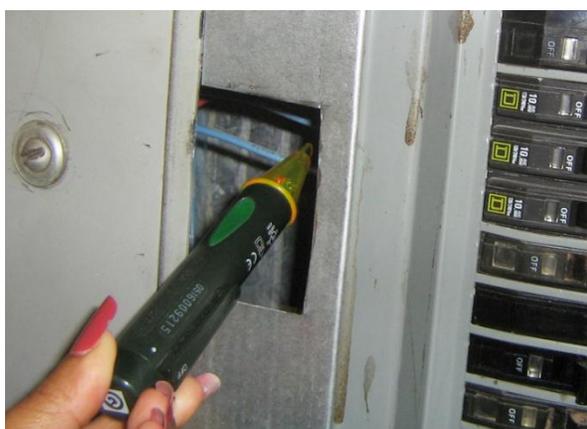
Figure 5 illustrates the breakdown of findings by hazard category or class. Electrical hazards are the most common findings, comprising 52% of the total. Fire safety hazards made up roughly 32% of the total, while the remaining findings were distributed among a number of categories. Electrical hazards include damaged or severely pinched electrical power cords, broken or burned outlets and switches, and junction boxes that were missing covers. The AOC is updating the electrical panels' directories, although the work is not yet complete. The maintenance of electrical panels remains a problem. Many panels are unlabeled or mislabeled. In addition, access to a number of electrical panels is blocked, which poses a threat in case of an emergency. Picture 1 displays an opening in an electrical panel circuit breaker box and energized contacts are exposed.

Picture 1: Electrical Box Hole Exposing Energized Contacts
