Office of Compliance
Safety and Health
FAST FACTS

Exposed Energized Wiring and Electrical Components

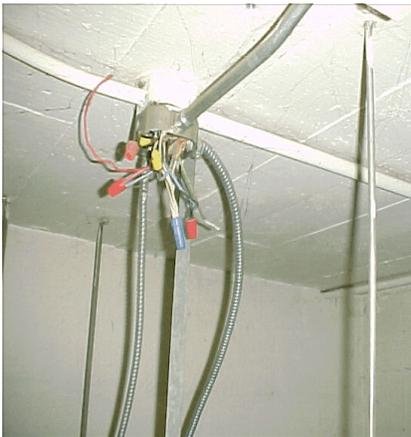
Figure 1: Electrical junction box without a cover.

The most common type of exposed wiring is open junction boxes, as seen in Figures 1 and 2. When junction boxes are left uncovered—typically after maintenance or installation—employees can easily bump into or touch the energized wires and become vulnerable to electric shock. In addition, if combustibles such as paper are stored near energized wiring, a spark or electric current could easily start a fire.

Both the Occupational Safety and Health Administration (OSHA) and the National Electrical Code NFPA 70 require that electrical wiring be kept free from all recognizable hazards, and that energized wiring be covered to prevent contact with other conducting materials. The Code of Federal Regulations (CFR) and the National Fire Protection Association (NFPA) also both require that live parts of electric equipment operating at 50 volts or more be guarded against accidental contact by approved enclosures, locations, and partitions. Warning signs that forbid unqualified persons from entering hazardous areas are also acceptable outside switch gear or transformer rooms. During the 108th Biennial Safety and Health inspections, OOC inspection staff found a total of 280 hazards that violated these regulations. Specifically, inspectors found uncovered

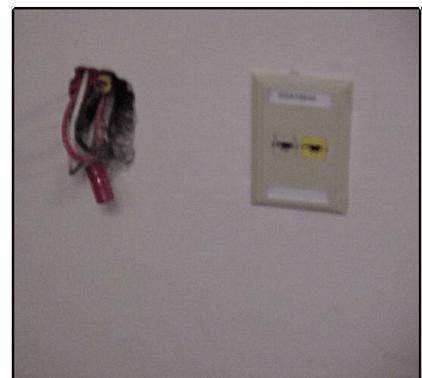
Figure 2: Electrical wiring exposed in high-traffic area

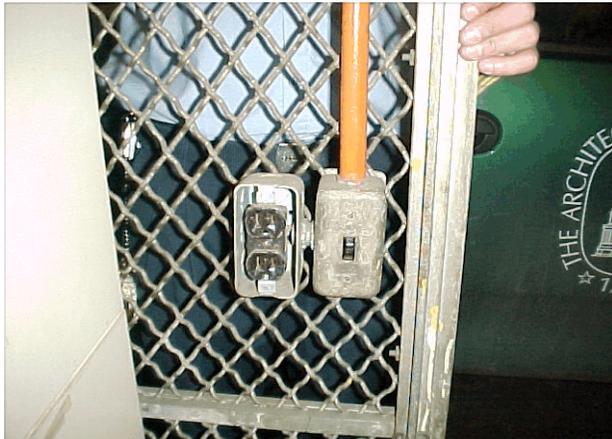
Other exposed wiring hazards include electrical outlets and switches that have either missing or broken covers, as seen in Figures 3 and 4. This hazard creates a risk of electrocution for any employee plugging in an appliance or turning on a light switch. Figure 3 especially demonstrates this hazard, as a person could easily be electrocuted while reaching around this corner to turn on the switch.

Figure 3: Electrical outlet without a cover.

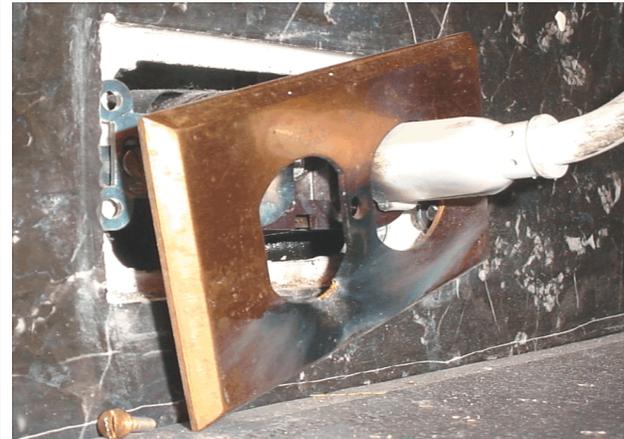
Figure 4: Electrical outlet with a broken cover.

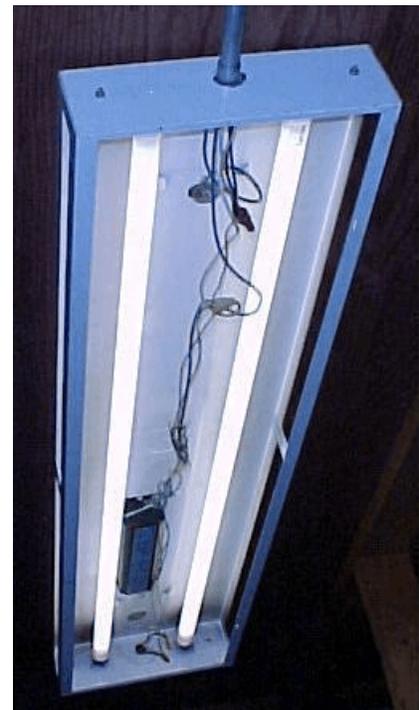
OOC inspectors have also frequently found uncovered light fixtures and open light bulb sockets. Light fixtures, especially fluorescent light fixtures, have energized wiring beneath their covers. Therefore, a cover must always be installed following installation or maintenance in order to prevent electrocution or fire. Figure 5 shows a fluorescent light fixture that does not have a cover, presenting a serious electrical shock hazard to all employees working in this area. Additionally, when a light bulb is broken or burns out and the socket is left open, the electrical parts inside the socket remain energized. For this reason, a defective bulb should always be left in a socket until the bulb is replaced.

Figure 5: Uncovered fluorescent light fixture exposing live wires.

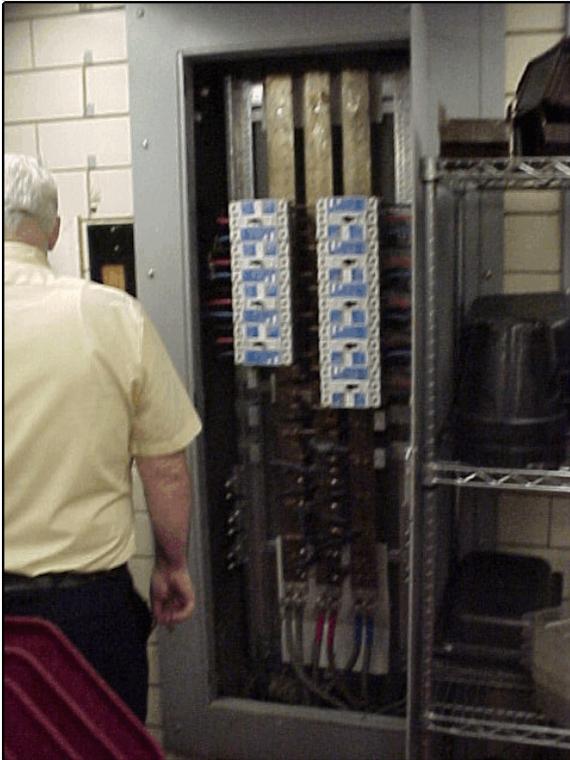
Electrical panels contain many junctions of live wires and other components, and they are required to be accessible at all times. These panels are also required to have a “dead front,” per CFR 1910.305(d). NFPA 70 describes a dead front as “without live parts exposed to a person on the operating side of the equipment.”(CFR 1910.305(d)) All live components must be

covered in this way so that anyone using the circuit breaker is safe from electric shock. The large electrical panel pictured in Figure 6 displays the hazard of a missing dead front. Not only are all the live components in this panel exposed, but also the panel's door lock is broken so that anyone might open the panel. Electrical panel boxes in commercial buildings should be locked and accessible by trained personnel only. The panel in Figure 6 is also located in a large dishwashing area, where a wet floor may lead to electrocution. Inspectors informed this employing office that this hazard presents imminent danger, and should be corrected immediately.

Figure 6: electrical panel with all live components exposed in dishwashing areas.

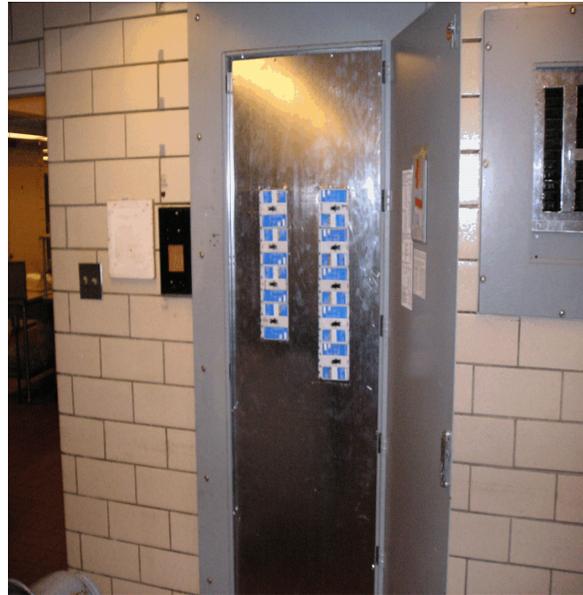
Figure 7: Same electrical panel after abatement. This panel now has a "dead front."
