The Capitol Power Plant

The OOC conducted a comprehensive inspection of the U.S. Capitol Power Plant (CPP) during the 111th Congress. The facility provides steam for heating and chilled water for cooling Capitol Hill buildings, but does not produce electrical energy for the Capitol campus. The CPP includes the Administration Building; the newly expanded West Refrigeration Plant (the East Refrigeration plant is being removed from service); the Boiler Building, which houses boilers, a bag house, storage areas, shops, a communication center and two smoke stacks; an ash collection building; three office trailers; two cooling towers; a coal yard including off-loading facilities for rail cars and an underground oil storage tank; a coal conveyor tunnel; a Hazmat storage shed; an emergency generator shed; the Blue Storage Building; Load Center One Building; several contractor trailers; two US Capitol Police kiosks; and the transfer building.

111th Congressional Inspection Findings

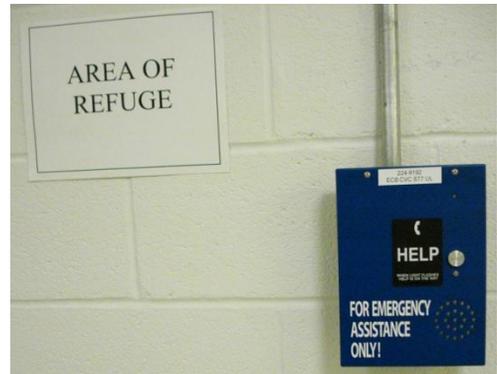
Picture 3: Excellent Emergency Communications System

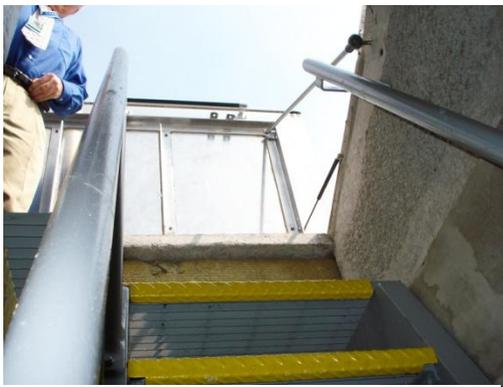
A notable remaining example of a slip and fall hazard is a historic spiral staircase that connects the ground floor of the Capitol with the second floor. There is no handrail and the steps are worn, creating a potential hazard. This finding was noted during the 110th Congress and continued into the 111th. The OOC has been informed that fabrication of the handrail is underway. Walking on a steep and at times wet and slippery metal roof was the only means to access the flag pole on the east front. The AOC constructed a stairway and hatch from the attic to the roof near the flag pole for safer and easier access. See Picture 3.

Picture 3: Example Of An Excellent Solution To A Fall Hazard
